A simple skylight retrofit in a Manhattan high-rise becomes a complete roof overhaul.

TOP Heavy

BY MARCO SHMERYKOWSKY, P.E.,
AND ANDREW STEINKUEHLER

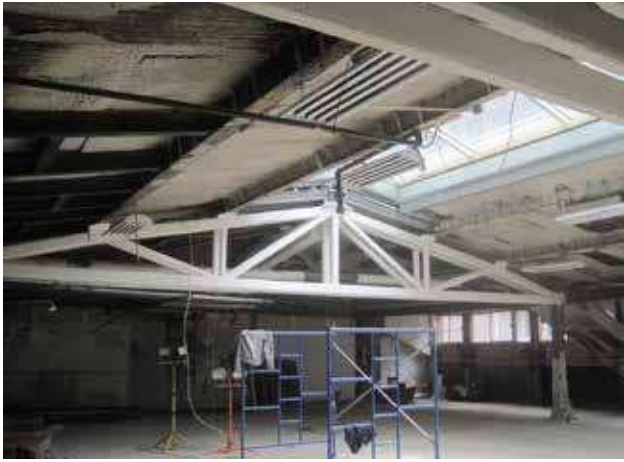
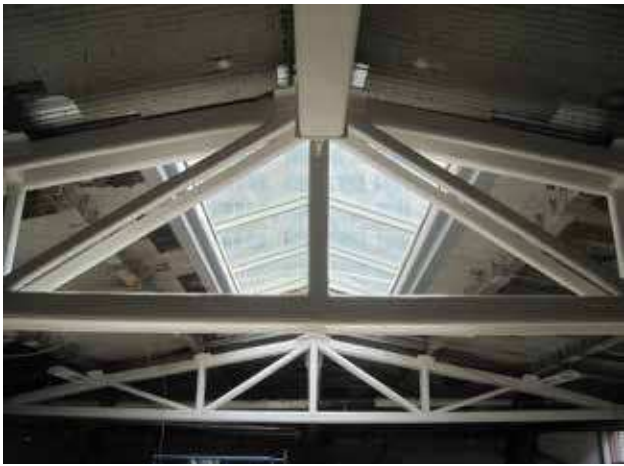
- ◀ ▲ The central roof structure consists of a standard pitched roof with the main ridge spanning in the east-west direction, and the “hips” of the roof are located on the east and west ends of the main ridge. The structure consists of a metal roof deck spanning between W8 purlins, and the purlins for the main roof span between two roughly 39-ft-long trusses supported on building columns; the original trusses had a depth of 6 ft at mid-span.

The project took place on the building's 18th floor, below the roof level. The central roof structure consists of a standard pitched roof with the main ridge spanning in the east-west direction, and the "hips" of the roof are located on the east and west ends of the main ridge. The structure consists of a metal roof deck spanning between W8 purlins, and the purlins for the main roof span between two roughly 39-ft-long trusses supported on building columns; the original trusses had a depth of 6 ft at mid-span. The roof hips connect to the main ridge purlins approximately 7 ft away from the main trusses, and the support for this connection point is created by the cantilevering of the ridge beam past trusses.

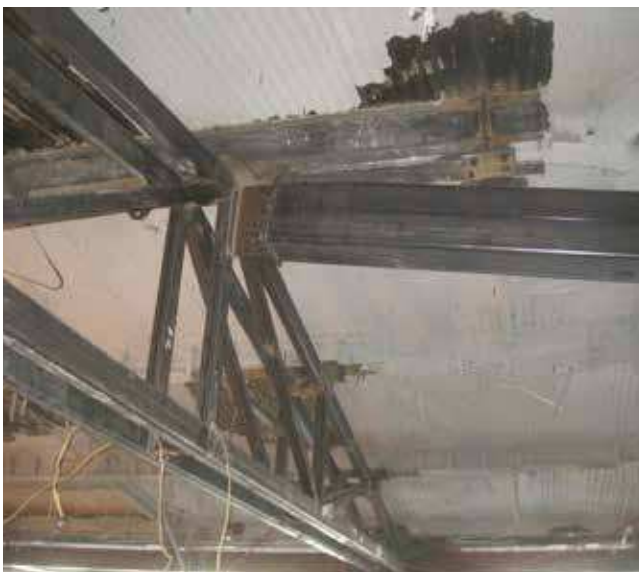
▲ ▼ At some point during the life of the building, three dormers were added to the original sloped roof area. The original structure consisted of cinder-concrete slabs, shallow beams and posts down to the floor below, and the main framing bay between building columns was approximately 26 ft wide. Within each of these bays, the original purlins were located 8 ft, 9 in. on center.

At some point during the life of the building, three dormers were added to the original sloped roof area. The original structure consisted of cinder-crete slabs, shallow beams and posts down to the floor below, and the main framing bay between building columns was approximately 26 ft wide. Within each of these bays, the original purlins were located 8 ft, 9 in. on center.

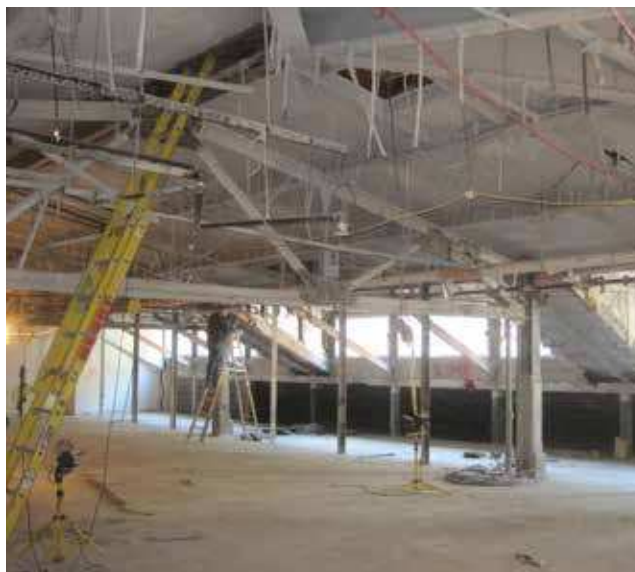
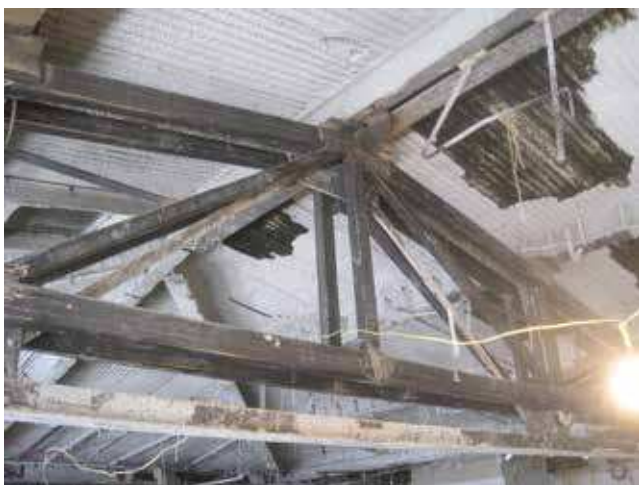
▲ ▼ The skylight also required an additional support structure that would work as an independent framing system and would be located above the roof deck surface. A box frame constructed of HSS12×8 and HSS12×4 members was developed by the engineers and arranged so that the new frame would bear on a total of eight support posts, which were coordinated with the roof purlins below.

The skylight also required an additional support structure that would work as an independent framing system and would be located above the roof deck surface. A box frame constructed of HSS12x8 and HSS12x4 members was developed by the engineers and arranged so that the new frame would bear on a total of eight support posts, which were coordinated with the roof purlins below. Small spans of deck there originally spanned to the ridge purlins were re-supported by ledge angles as required.

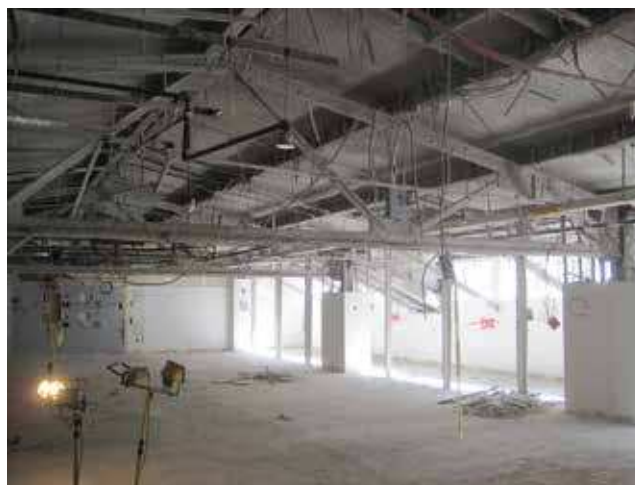
With goal one—opening up additional floor space—achieved, the team now had to figure out a way to increase headroom. We opted to replace each existing truss with two shallower trusses on either side. Each of these trusses spanned 39 ft, 3 in., with a depth of 5 ft at mid-span, and were constructed with HSS6×3 chords and HSS3×3 vertical and diagonal members. These truss pairs would be supported on brackets attached to the sides of the existing columns.

as architecturally exposed structural steel (AESS) rather than cladding it or installing a drop ceiling. The team felt that hollow structural sections (HSS) would lend the new trusses a cleaner, more aesthetically-pleasing profile (a truss made up of angles would need to be connected via bolted connections, which would both decrease available headroom and lack the streamlined look of a welded HSS truss).

The installation process posed its own challenges. Luckily, the top floor was unoccupied and a freight elevator made removing existing steel and bringing up new members possible. As the new trusses were being installed, the design team had to be sure to prevent deflections in the existing roof structure. Therefore, the contractor was instructed to preload the trusses by jacking both ends of each truss pair for a predetermined amount. Once the new truss pairs were preloaded and connected, the original trusses were removed. Finally, to engage

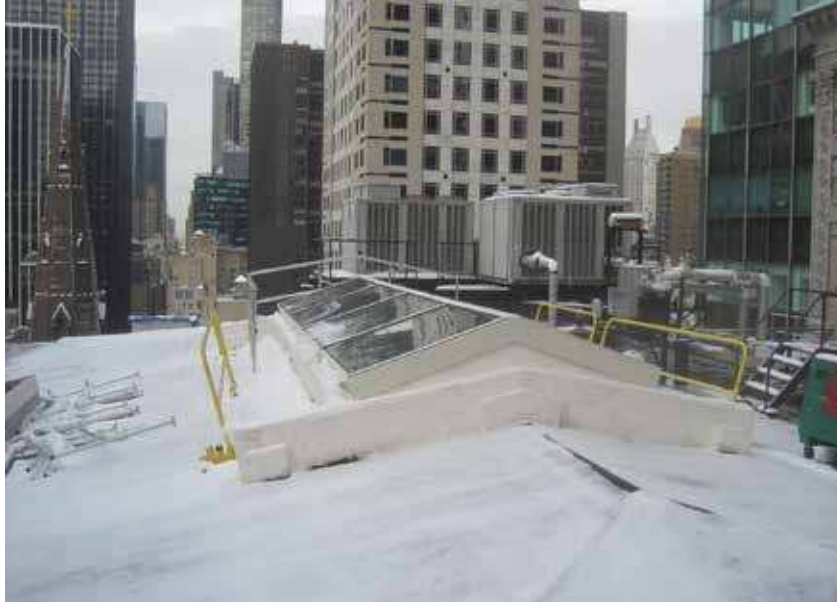
◀ An exterior view of the 25-ft by 8-ft skylight.

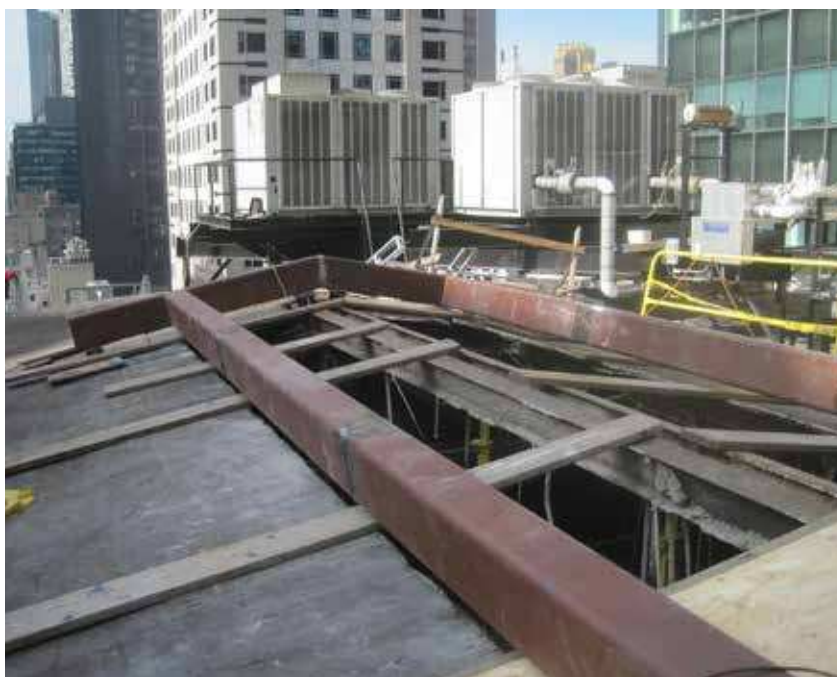
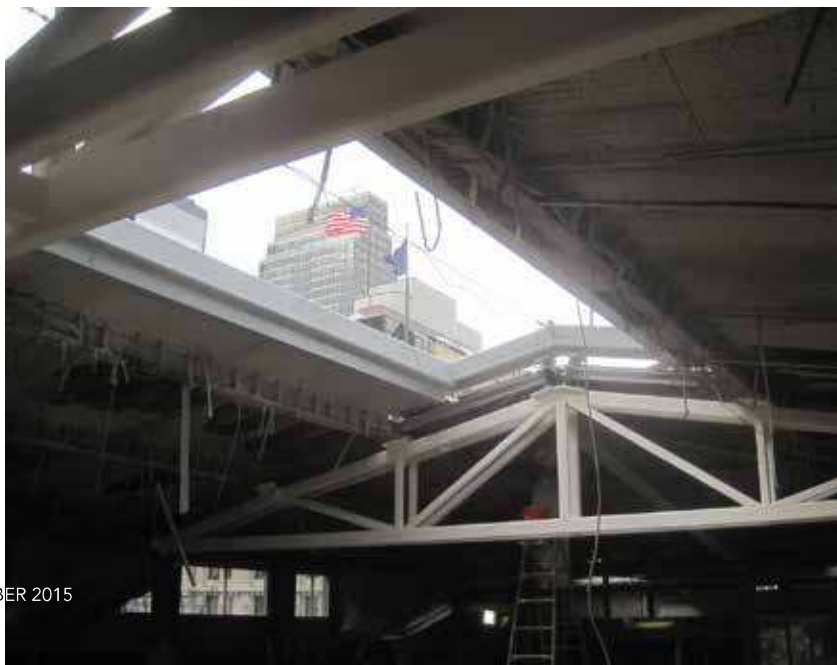
▲ ▼ The structural team decided to support the roof hips with new ridge beams that would span between existing building columns, which were conveniently located at the center of each roof hip's base as well as at the center of each exterior truss.

After careful consideration, the structural team decided to support the roof hips with new ridge beams. These ridge beams would span between existing building columns that were conveniently located at the center of each roof hip's base as well as at the center of each exterior truss; the new beams were simply supported.
